Riparian Vegetated Buffer Zone performance challenges in the Black Brook Study Watershed in New Brunswick

Dr. Lien Chow, Agriculture and Agri-Food Canada, Fredericton, NB
Jean-Louis Daigle, P.Eng., Eastern Canada Soil and Water Conservation Centre, Saint-André, NB

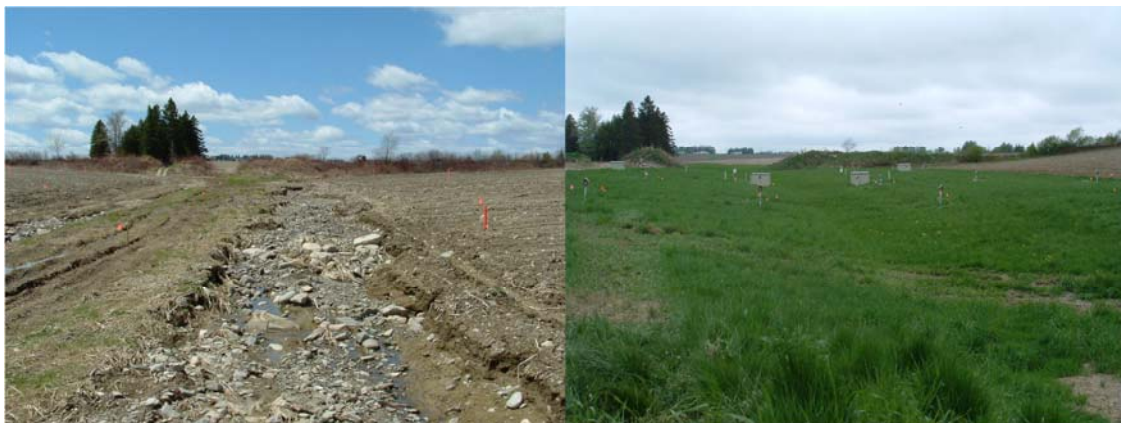
Fig. 1. Photographs showing before (left) and after (right) implementation of a grassed waterway and vegetated riparian buffer soil and water conservation system.

On agricultural land, a riparian buffer is a permanently vegetated strip of land next to a stream or a body of water. They are designed to protect water quality by reducing the amount of surface runoff, sediment, nutrients and pesticides reaching watercourses. Photographs showing an intermittent stream landscape at the edge of two farm fields in New Brunswick before and after implementation of a vegetated riparian buffer are shown in Fig. 1.
